# Large scale multi-level hearing loop installation at Barclays' London HQ

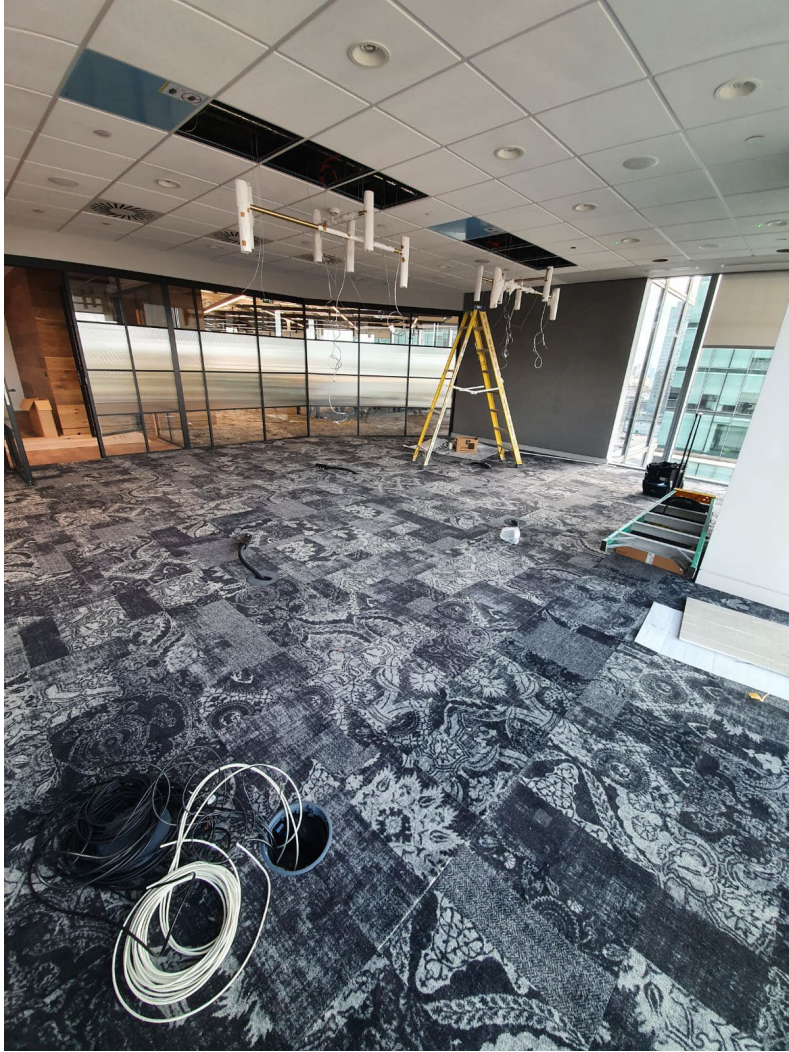
PERIMETER LOOP INSTALL

Rooms adjacent to each other have been looped with a phased array configuration to contain the sound while corner rooms will have a perimeter loop layout.
